CHARACTERISTICS OF HIGH-SPEED CYCLIC TEST OF BEAM-COLUMN JOINTS

Rajesh P. Dhakal and Tso-Chien Pan

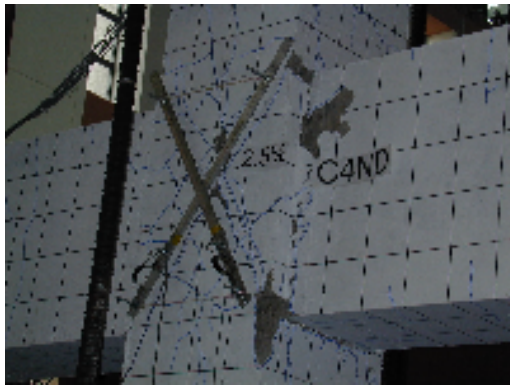
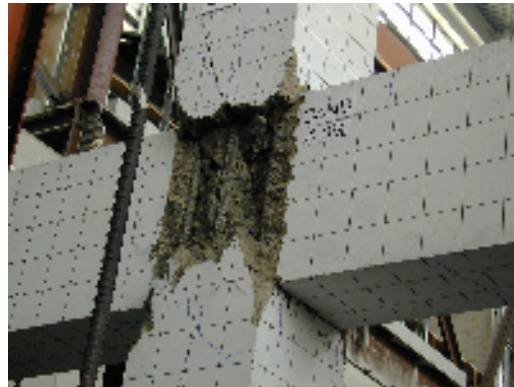
Figure 5

As the loading was continuous, the initiation and propagation of the diagonal cracks in the joint could not be monitored until the end of 2.5% radian story drift cycles. The damage condition of both joint faces observed after 2.5% and 4% radian story drift cycles, however, are shown in Figure 5. As shown in the photographs, damage was mainly concentrated in the joint panel, and only a few cracks could be observed in the members. Cover spalling had already started in both faces of the joint at the completion of 2.5% radian story drift cycles. A few vertical cracks in the column extended to the joint in addition to the uniformly spaced flexural cracks. Beams had comparatively fewer cracks than columns did. Opening of the corners at the joint-member interface could also be noticed during the first damage inspection. The test was terminated after the cycles corresponding to 4% radian story drift angle had been applied, when the specimen showed severe damage and the story shear force degraded significantly. At this stage, concrete cover spalled off from both faces of the joint, thus exposing the main reinforcing bars inside the joint. Apart from this, concrete pieces also came out from the corners along the joint-member interfaces.

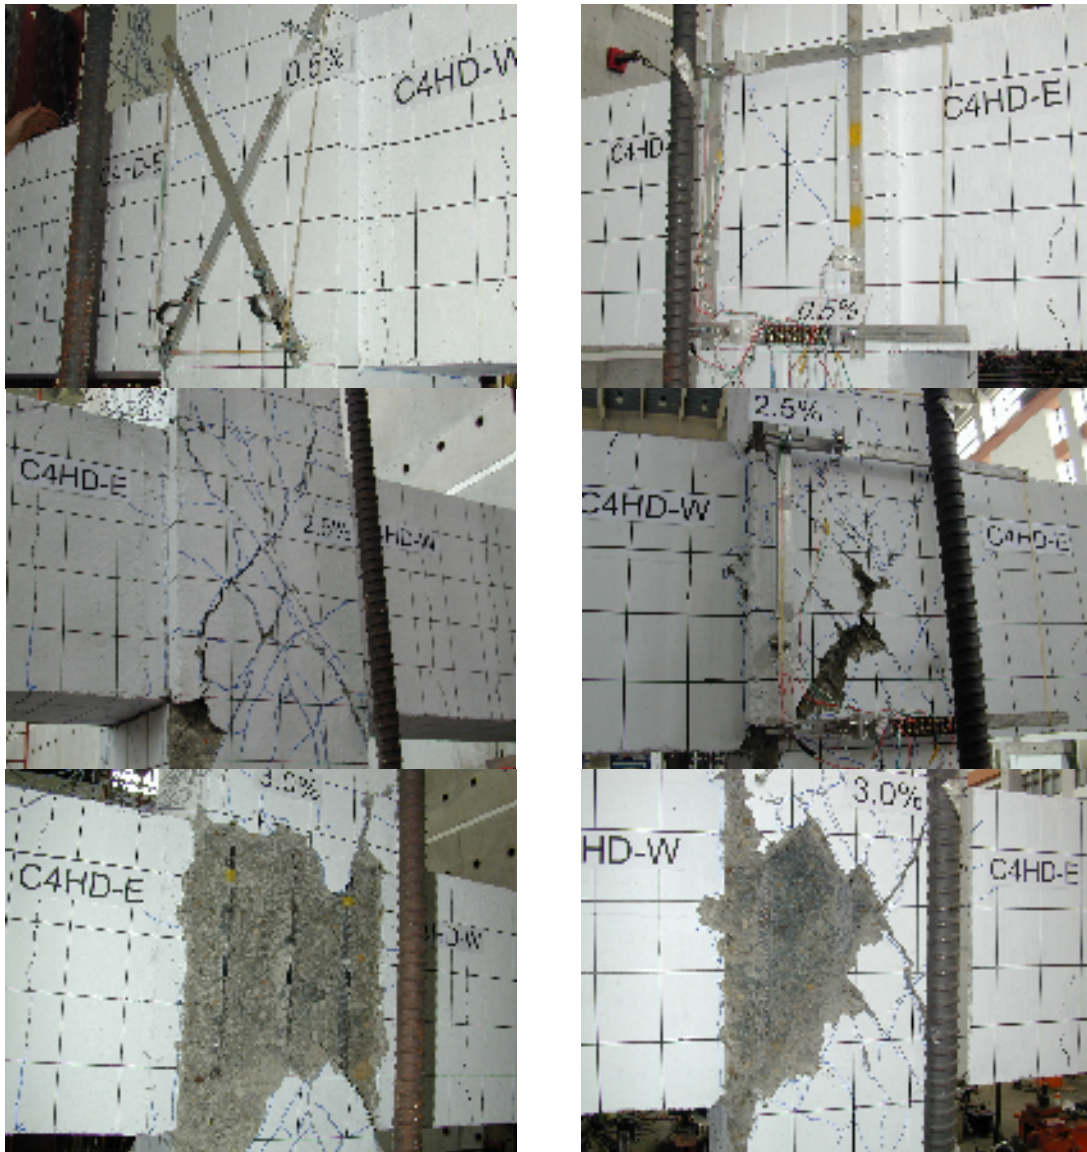
Figure 11

The conditions of both faces of joint after the emergence of the first crack, after completion of 2.5% radian story drift cycles, and at the end of the test are shown in Figure 11. As shown in the photographs, the first pair of diagonal cracks was seen after 0.5% radian story drift (± 15 mm) cycles were applied. Concrete cover spalling had already started at both faces after 2.5% radian story drift cycles. At this stage, the first pair of diagonal cracks had opened

significantly, while the other cracks remained thin. Cracks in the joint faces extended beyond the joint-column interface, and more flexural cracks could be observed in the columns than in the beams. A big piece of concrete had even spalled off from beneath the joint front face. In addition to the cracks in the joint faces and members, vertical cracks along the joint-beam interfaces could also be seen. This might be due to the alternate opening and closure at the joint corners. The specimen deteriorated quickly on further loading, and the test was terminated after 3% radian story drift (± 90 mm) cycles had been applied. At the final stage, concrete cover spalled off from both faces of the joint, thus exposing the main reinforcing bars inside the joint.

(b) Displacement, actuator force and the story shear force recorded by the test software.
- Figure 11. C4HD joint faces observed after the first cracking, and after 2.5% and 3% radian story drift cycles.
